MATERIALS FOR REPAIRING DAMAGED INSULATION ON PIPES WITH BITUMINOUS MASTIC AND POLYETHYLENE COATING

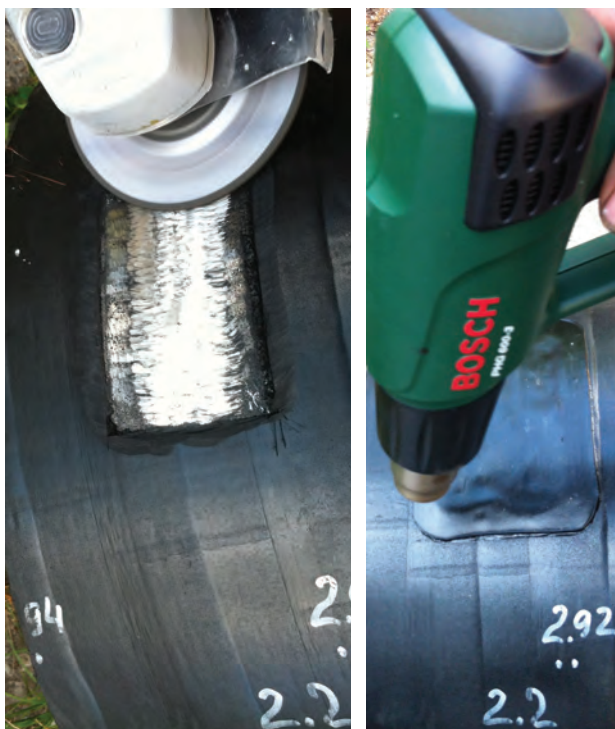
The set of materials is to be used for repairing penetration and surface damages of pipe insulation

The set includes a primer, an adhesive filler, and a double-layered polyethylene tape. The technical characteristics of the repaired coatings meet the requirements of DSTU 4219-2003. The repair materials are referred to the 4th hazard class

No preheating of the pipe body at the repair site is required, which eliminates any risk of damaging the base coat integrity and significantly reduces energy consumption
